Successful retrieval of fractured pressure wire tip (FFR) by hybrid technique

Coronary angiography and angioplasty are relatively safe procedures but not without complications. We report an interesting case of effort angina taken for angioplasty of the LCX and assessment of fractional flow reserve (FFR) for the LAD artery lesion in which the tip of the pressure wire was broken and embolised to the LCX while trying to retrieve it. This is the first case report using a hybrid technique with a slip catheter for the successful retrieval of a fractured FFR wire.

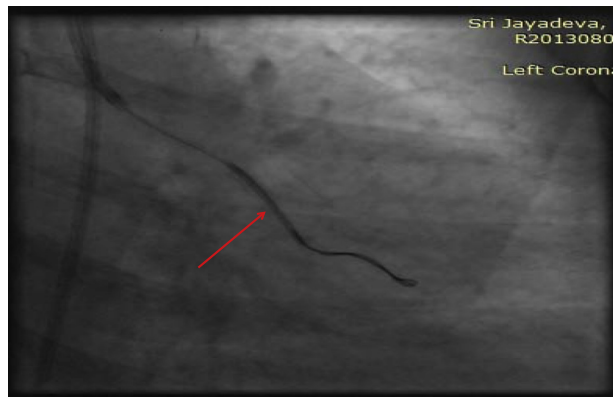
Figure 7. Using Slip-Cath (arrow) with floppy wire to retrieve broken FFR wire from OM2 vessel.

of a large catheter through smaller sized access site sheaths, polymer aging or a combination of factors [3]. One rare report describes the retrieval of a fractured pressure wire [4]. We used multiple techniques to retrieve the broken pressure wire. Single wire, twin wire, and even three wires were used but none of the techniques were successful. Finally, the angiographic catheter, Slip-Cath [5], worked. The Slip-Cath is an angiographic catheter available in 3–5 French size with a length of 40–150 cm (Fig. 5). It has a hydrophilic coating which allows for ease of insertion. Torque control and kink resistance are better in Slip-Cath due to its design, which is made of nylon with stainless steel braiding from hub to tip. It is used more commonly in peripheral interventions like carotid and peripheral vascular interventions. We report its use, for the first time, in the retrieval of a broken wire tip. Using a Slip-Cath measuring 125 centimetres, we were able to provide greater stability to the helix of the floppy wire with the broken pressure wire. The Slip-Cath has a smaller diameter than the guide catheter (we used 4 French); obviously less space was available for the pressure wire to move around or curve around. The principle we used was very simple and based on the use of a microcatheter to cross chronic total occlusions like a mother–child technique. Slip-Cath accepts a 0.038" wire. After making a helix of one 0.014" floppy wire with the broken FFR wire, it was easy to pull them up to the guide catheter tip with the additional covering of the helix by the Slip-Cath. The concept behind the procedure was to make the helix and to pull up to the aortic root by whatever means, knowing that the subsequent path (from aortic root to groin) would be much easier. Slip-Cath supported this by giving a covering to the helix which was still inside the artery. There were fewer chances of slippage with a Slip-Cath (obviously a helix will have more places to move inside a 7F guide
